Pilotage Notes for River Tamar between Weir Quay and just short of Newquay (with corrected lat and long)

Michael Tucker, Weir Quay Sailing Club, April 2011. mctucker@aol.com, 01822 840035

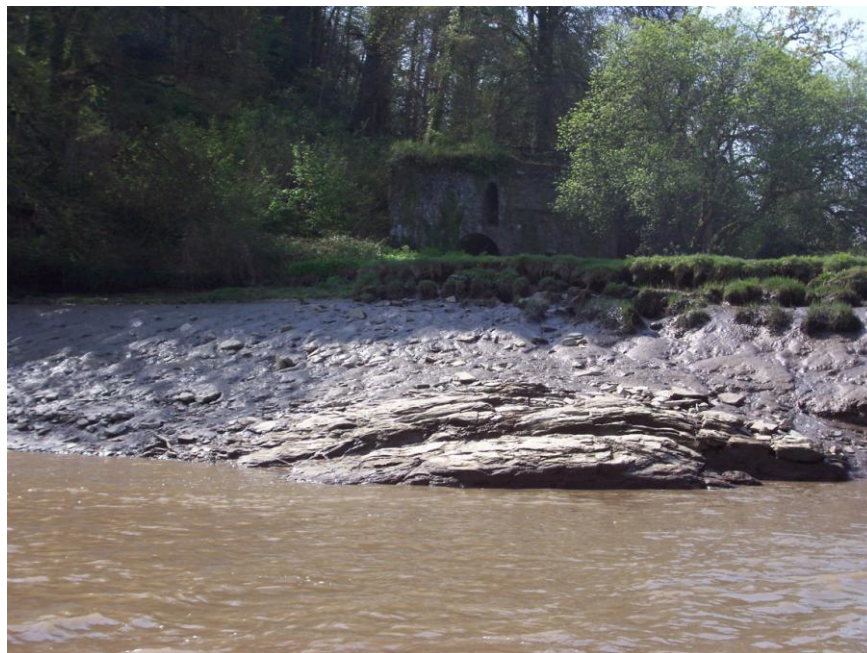
Rock by lime kiln (Quay (ru)) on Imray chart C14) at Cotehele – tide still ebbing! [$50^{\circ} 29.22.32N 4^{\circ} 13.27.46'W$]

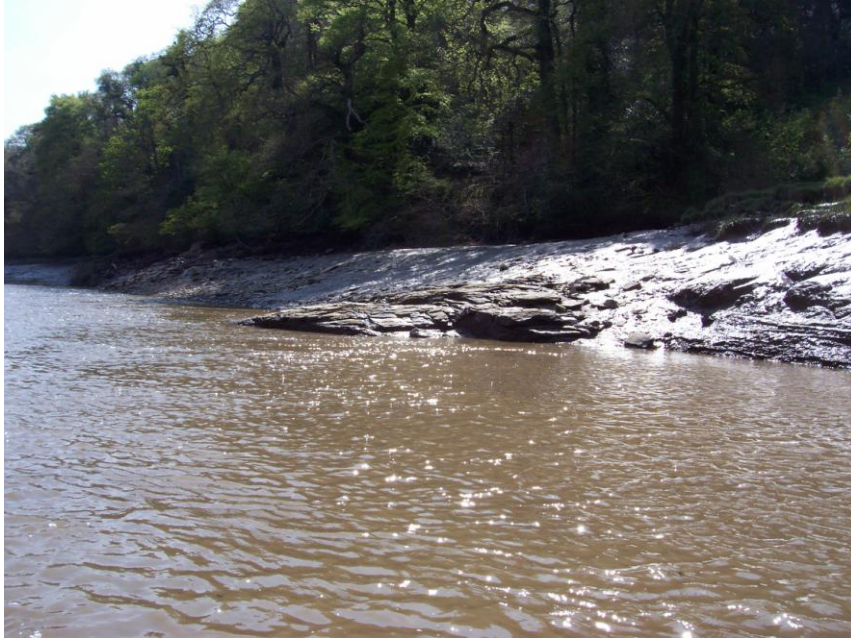
This rock stands out by about 10m – you can just see that it is implied on the chart but it's not noted as a specific hazard, possibly because the bank above and besides the rock has been eroded since the chart survey. I think it is a hazard because it's right on the line that a prudent mariner is likely to take approaching Cotehele.

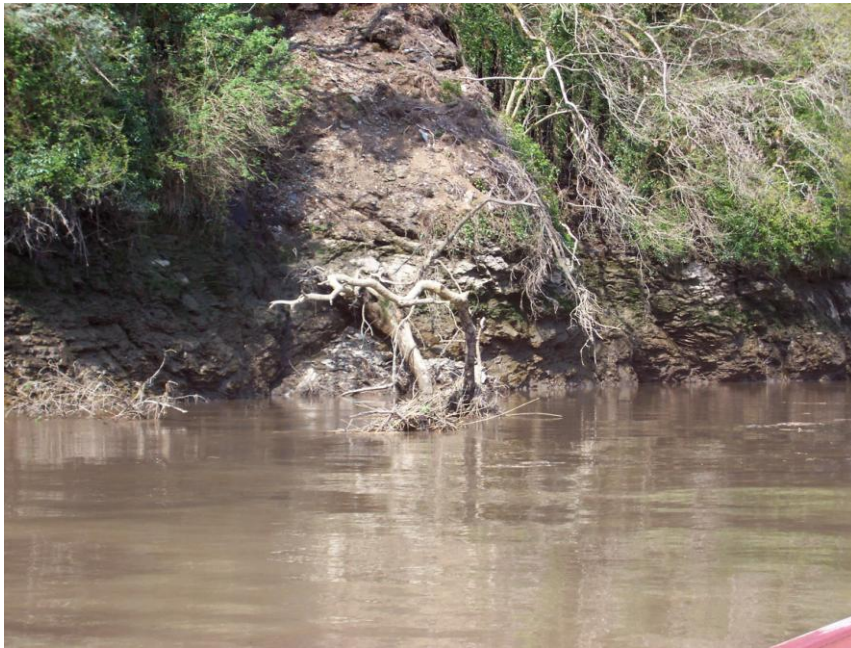
This photo does not show how far into the channel this tree extends, probably to at least 15m, even the upper limb may be underwater a few hours before and after high water. I struck several underwater objects when trying to get immediately downstream of the tree to photograph it. It's on the outside of the last bend before Calstock in the deep water channel. [50° 29.51.85N 4° 13.16.28W]

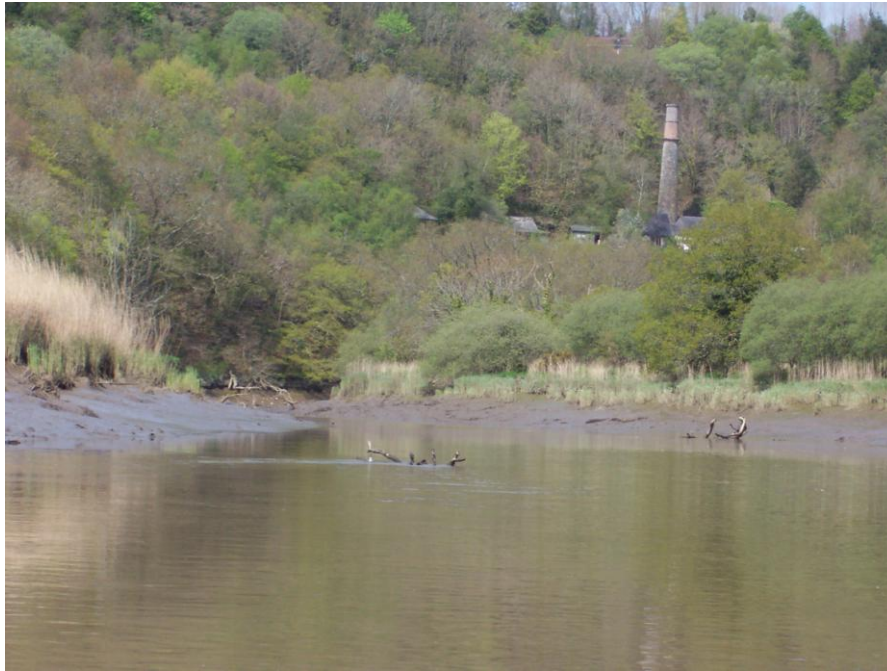
Sunken tree in the middle of the channel at Okeltor Sewerage Works [50° 29.48.82N 4° 11.39.70W].

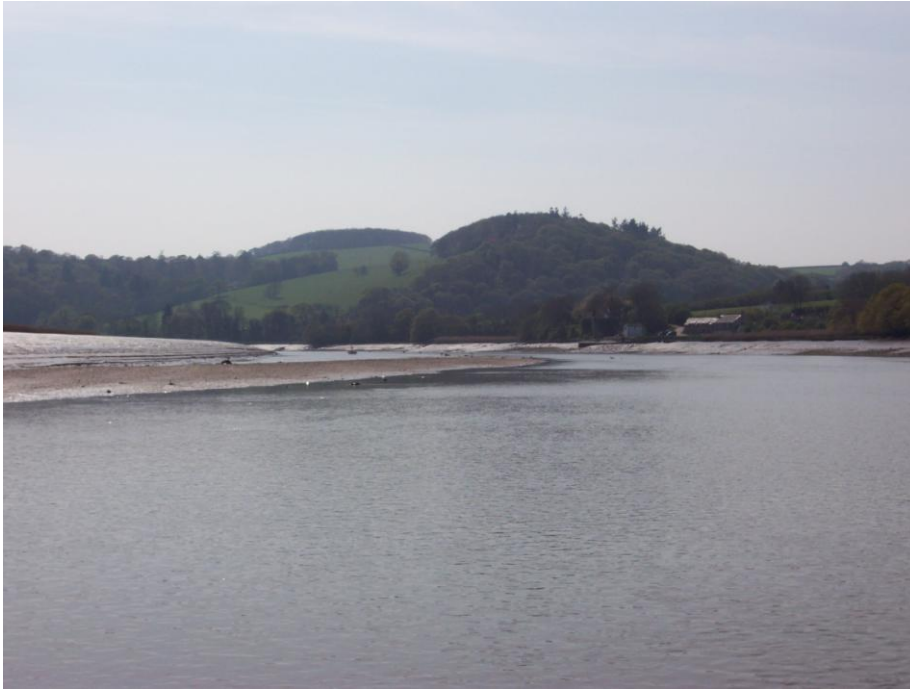
*Sandbar opposite Halton Quay which roughly follows the line of moorings, one of which had the mooring block on dried sand.
Taken at or very close to LW: nearly all of this water was less than 0.4 deep.*

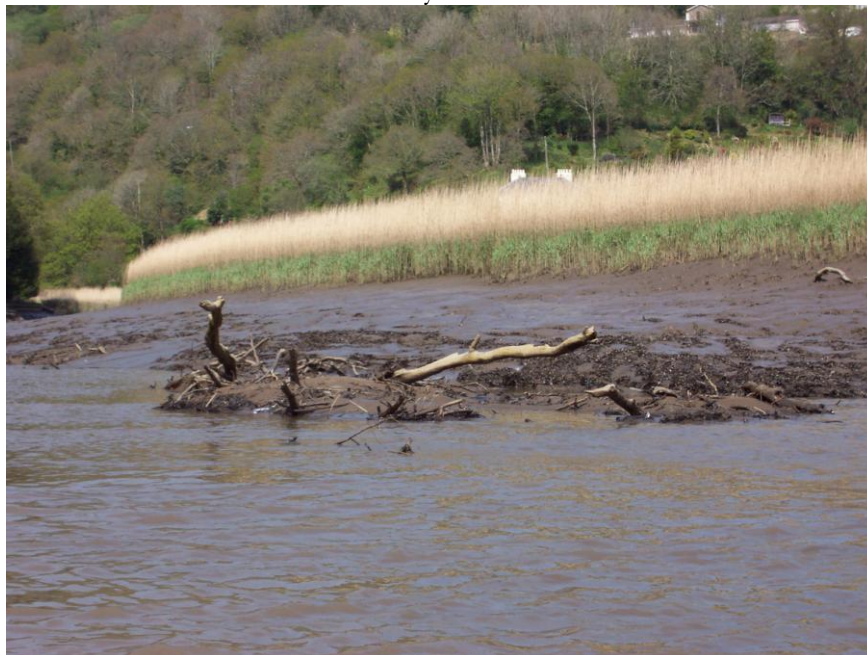
Debris on inside of bend, downstream: just below the final bend into Calstock. All covered at HW. All the other downstream insides of bends had similar debris.

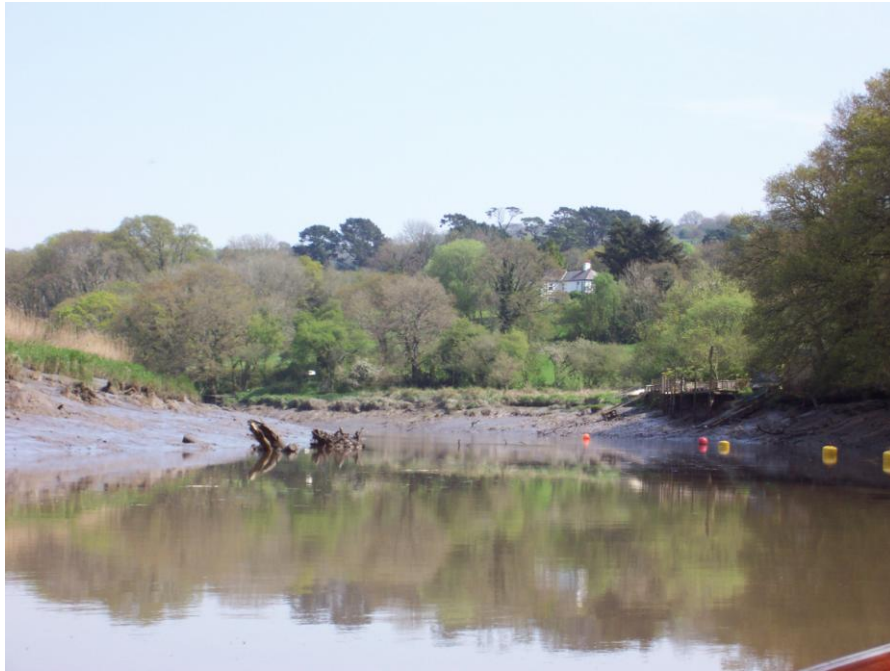
Debris on inside downstream of bend at Tuckermarsh

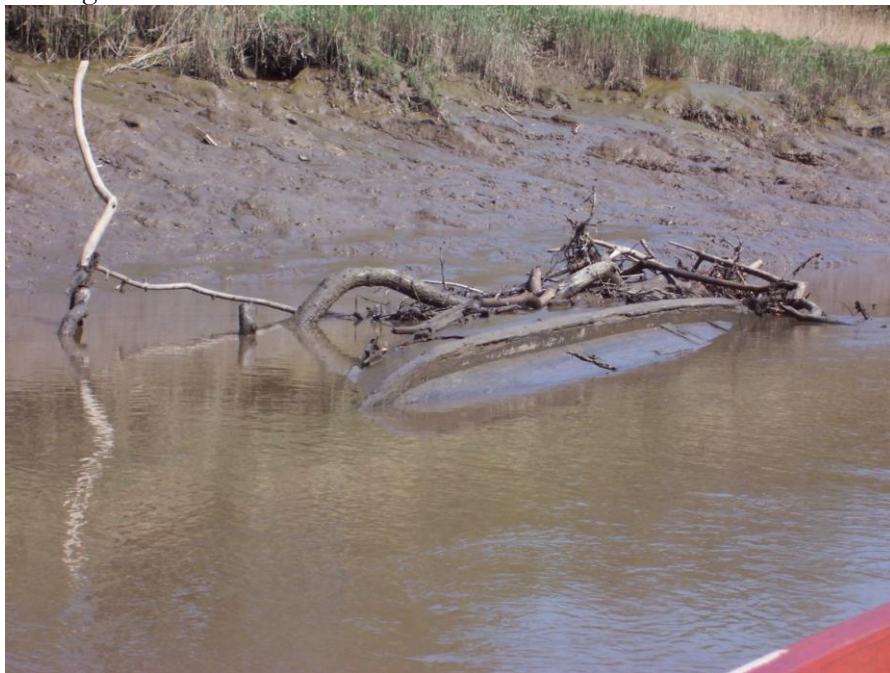
Wreck of wooden vessel about 20 foot LOA. 50° 29.55.92N 4° 11.33.59W. It is visible on Google Earth and has been there for several years.
